**HUNTER VALLEY
OPERATIONS**

**Annual
Environmental
Review**

March 2019

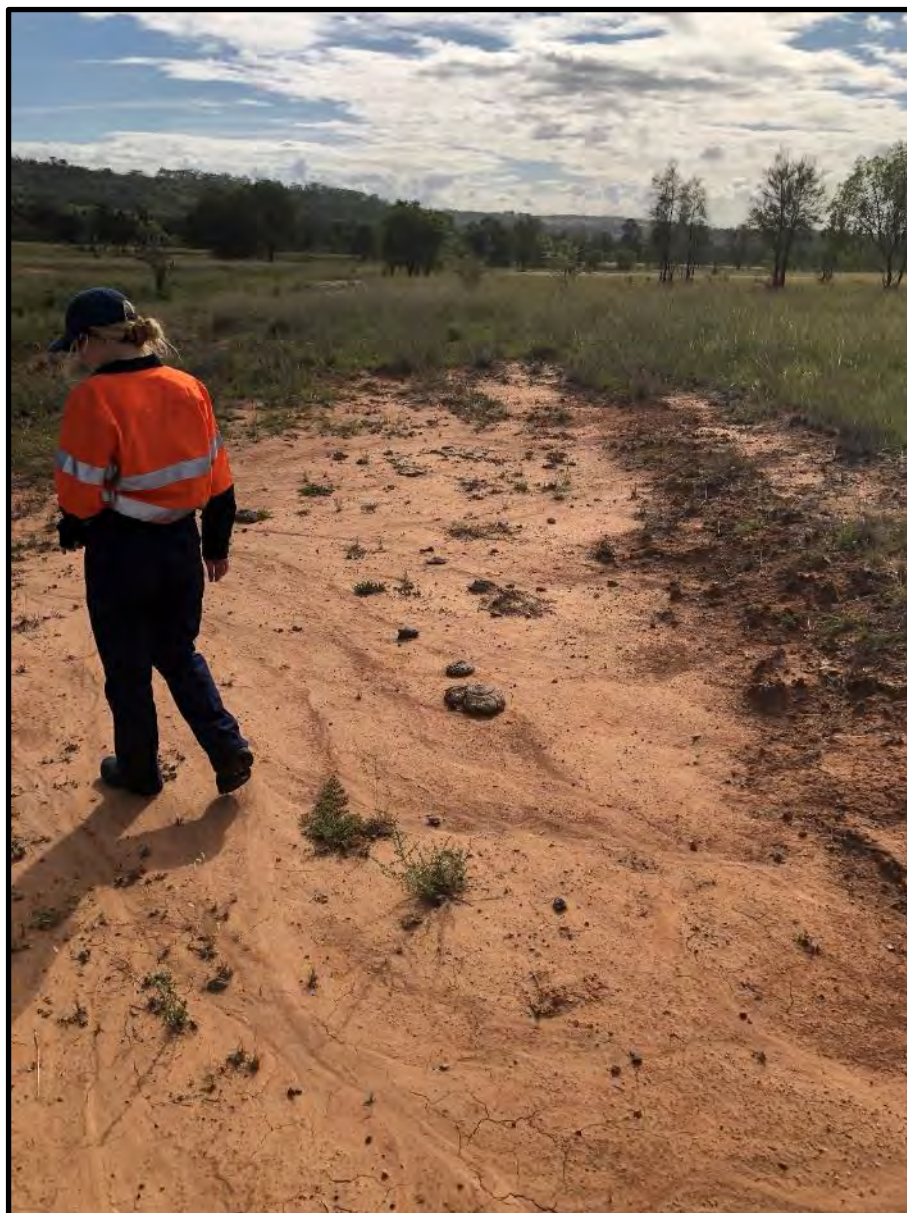
Evidence of stock at site HVO-291 (dung throughout exposure)

With this in mind, it is recommended that cattle are excluded from that part of the Mitchell Pit area containing Aboriginal heritage sites until these sites are salvaged. HVO currently have a valid AHIP covering the majority of the recorded Mitchell Pit sites, which provides the legal authority to salvage at any time, in accordance with the AHIP conditions. If future mining development is likely in the area in the near future, then the salvage of these sites before any further potential cattle damage would be prudent. Cattle should continue to be excluded from those areas where Aboriginal heritage sites are located but that are not covered by the Mitchell Pit AHIP.

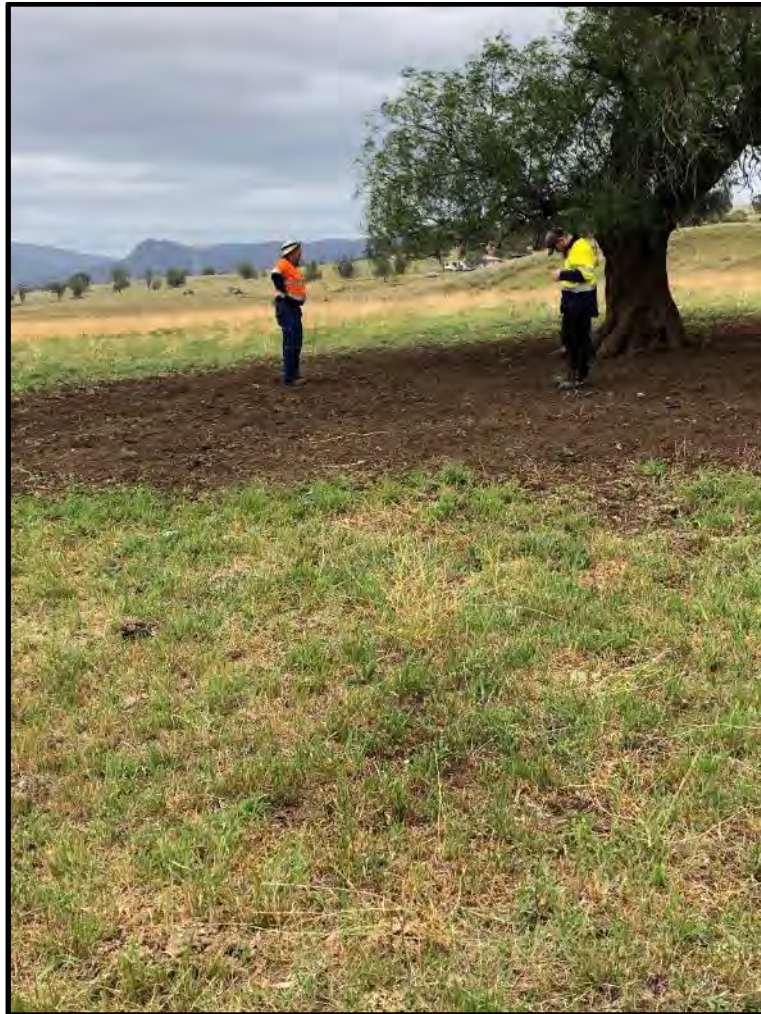
HVO-1123 and cattle disturbance around tree

surface. The site was not relocated during this inspection. To prevent further disturbance, it is recommended that cattle proof fencing be installed around the tree to remove cattle from the immediate area.

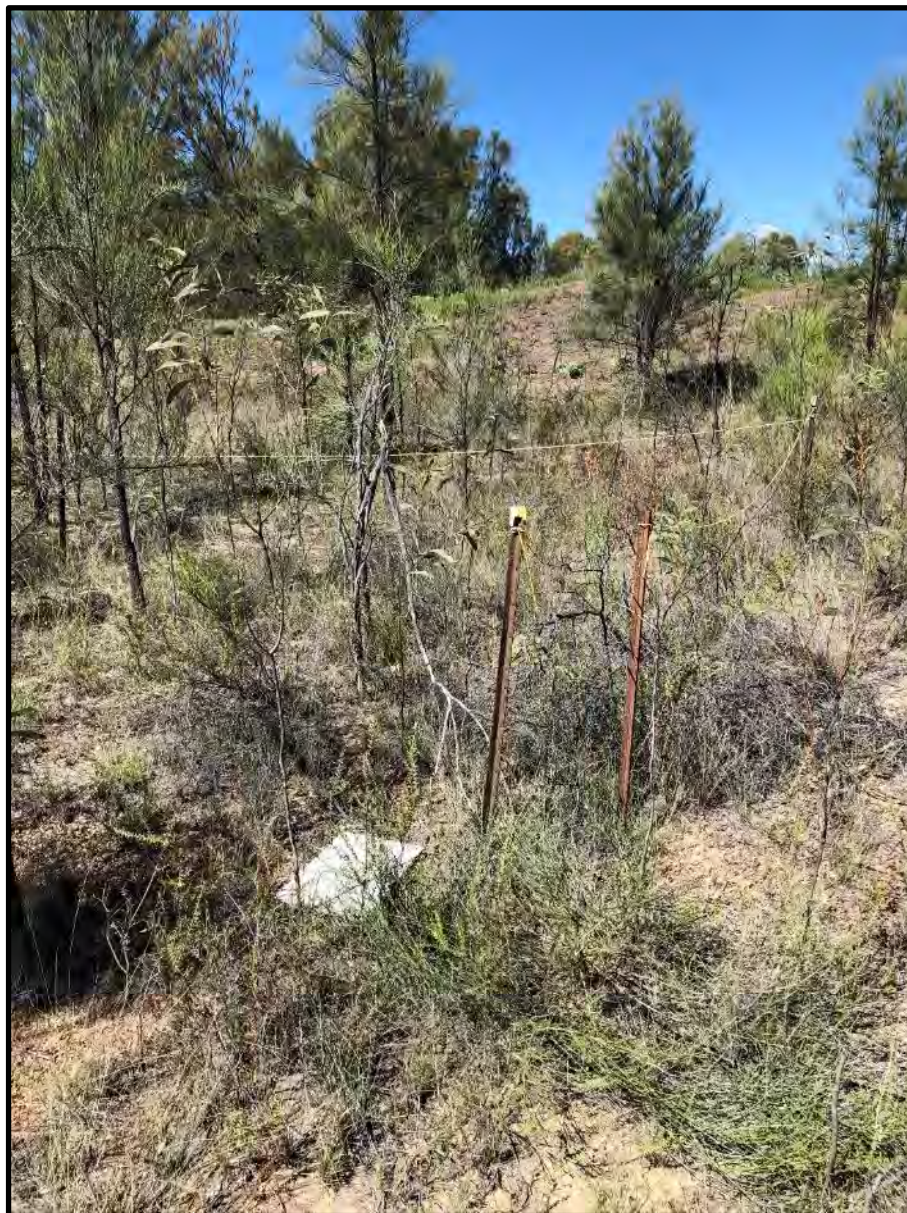
An example of dilapidated barricading at HVO-76
