HUNTER VALLEY OPERATIONS

MONTHLY ENVIRONMENTAL MONITORING REPORT APRIL 2024

HVOOC-1797567310-4954

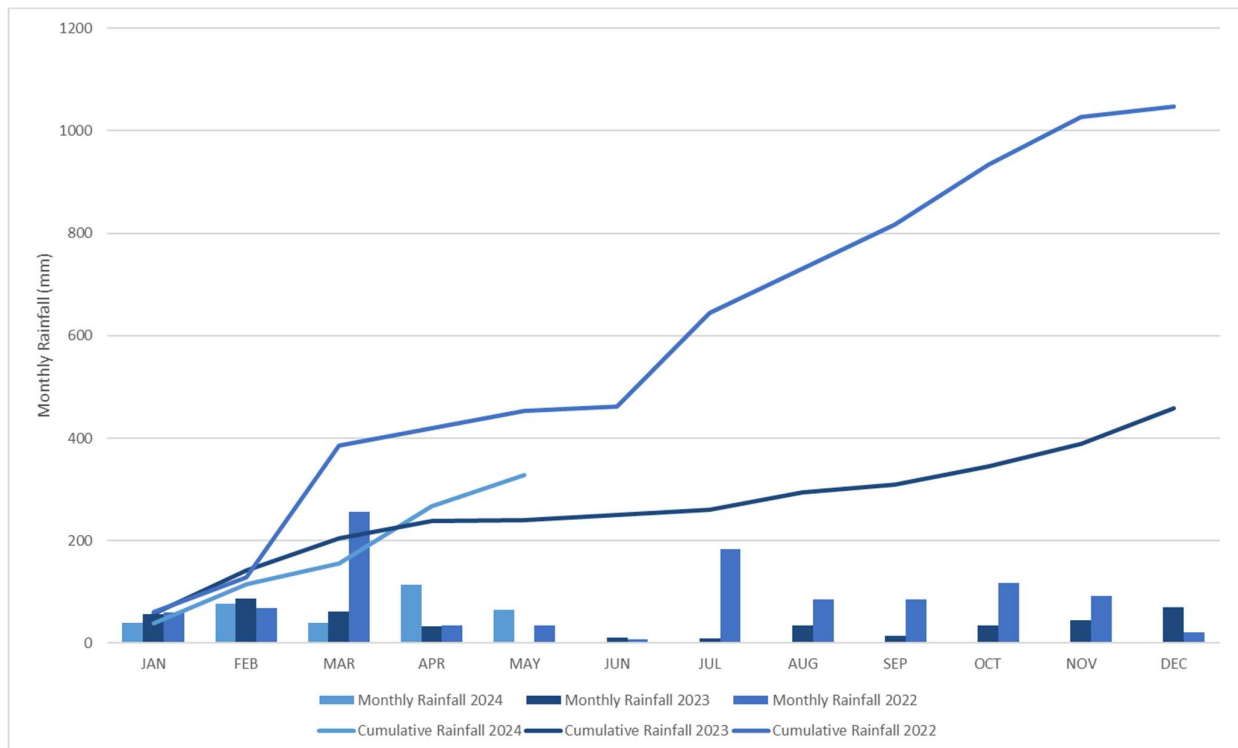
Figure 1 - Rainfall Summary 2024

Rainfall recorded at the HVO Corporate weather station during the period is summarised in **Table 1**. The 2022, 2023 and 2024 trends are shown in **Figure 1**.

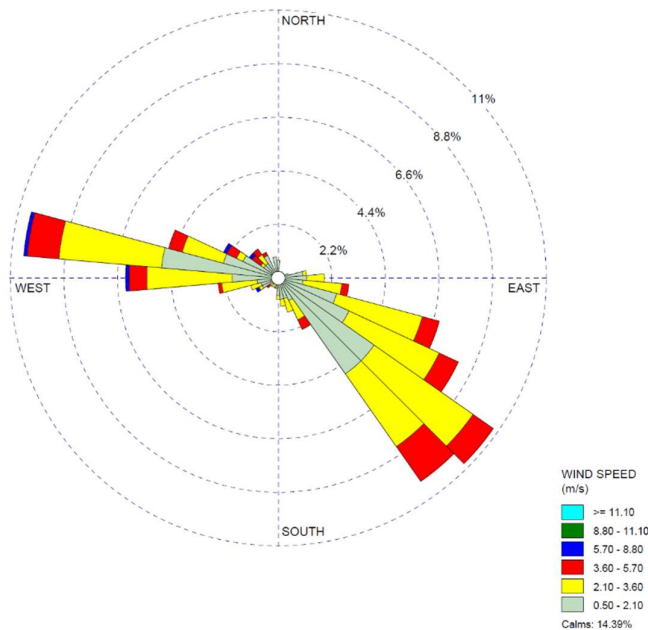
Figure 2 – HVO Corporate Wind Rose for the Reporting Period

Figures 2 and 3 wind roses show wind speeds and directions during the reporting period at HVO Corporate and Cheshunt meteorological stations respectively. South easterly and west north westerly winds were prevailing at HVO Corporate, whilst south easterly and north westerly winds were prevailing at HVO Cheshunt.

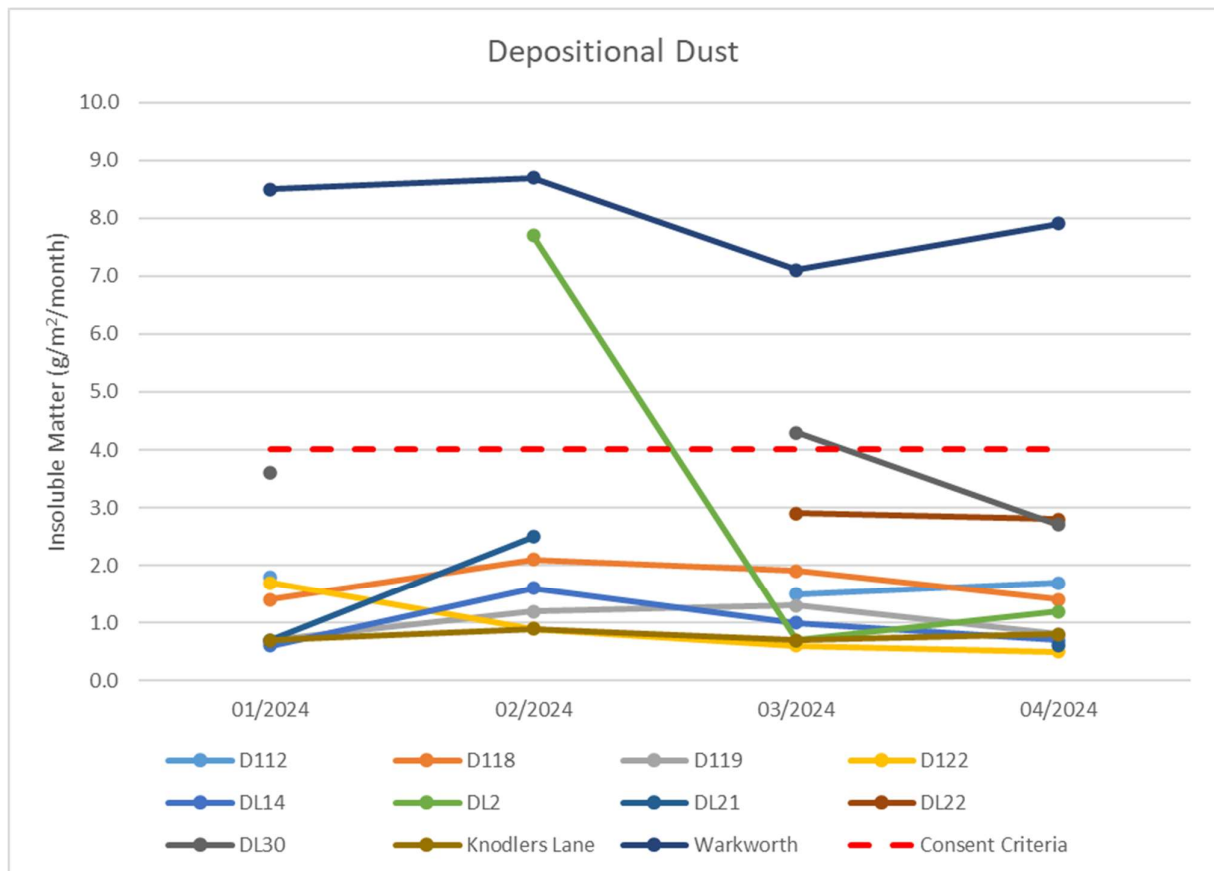
Figure 5 – YTD Depositional Dust Results as at end of the Reporting Period

Figure 5 displays year-to-date (YTD) insoluble solids results from depositional dust gauges during the reporting period compared against the annual impact assessment criteria. Any monthly results deemed to be contaminated (due to presence of bird droppings, insects, etc.) are not displayed. An assessment of HVO's contribution against the long-term impact assessment criteria will be provided in the 2024 Annual Review.

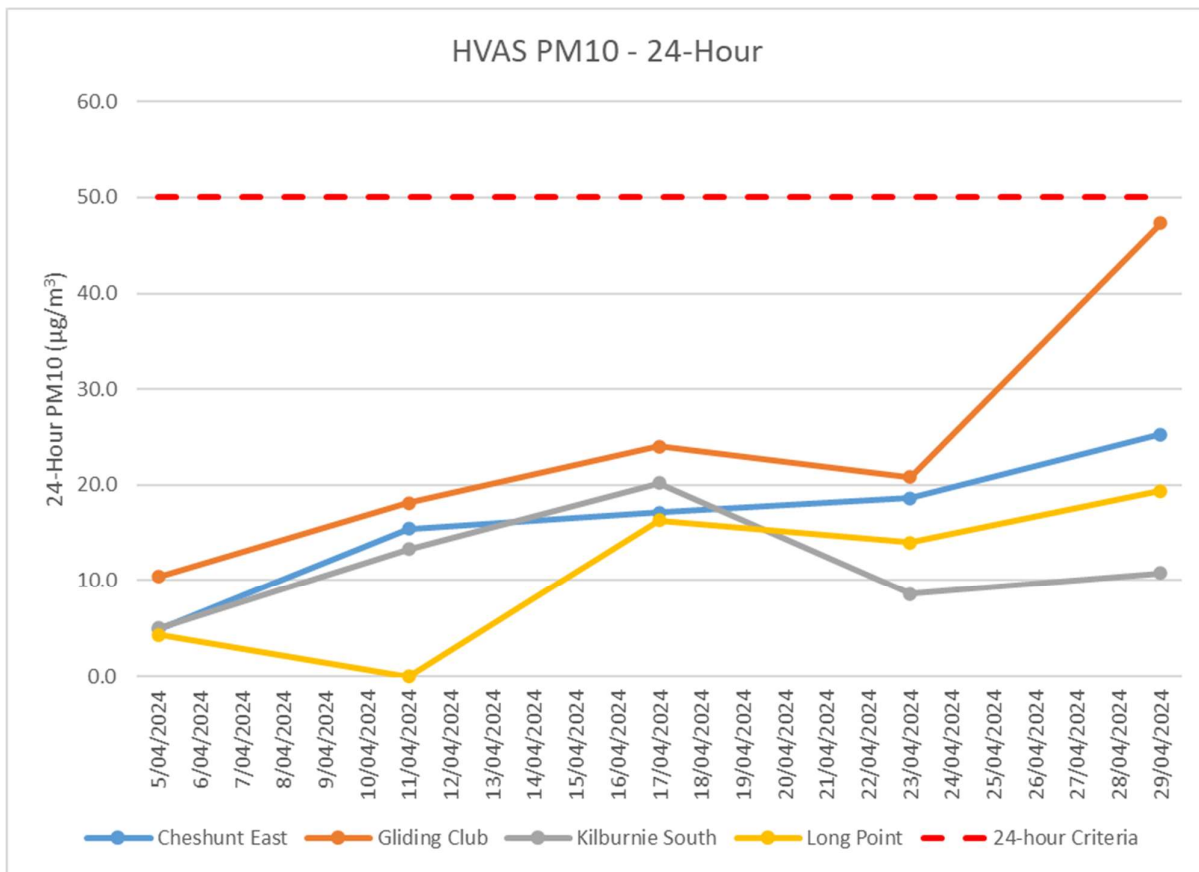
Figure 6 – Individual PM₁₀ Results for the Reporting Period

Figure 6 shows individual PM₁₀ results at each monitoring station against the short-term impact assessment criteria of 50µg/m³ for the reporting period. All monitors were below the short-term impact assessment criteria during the reporting period.

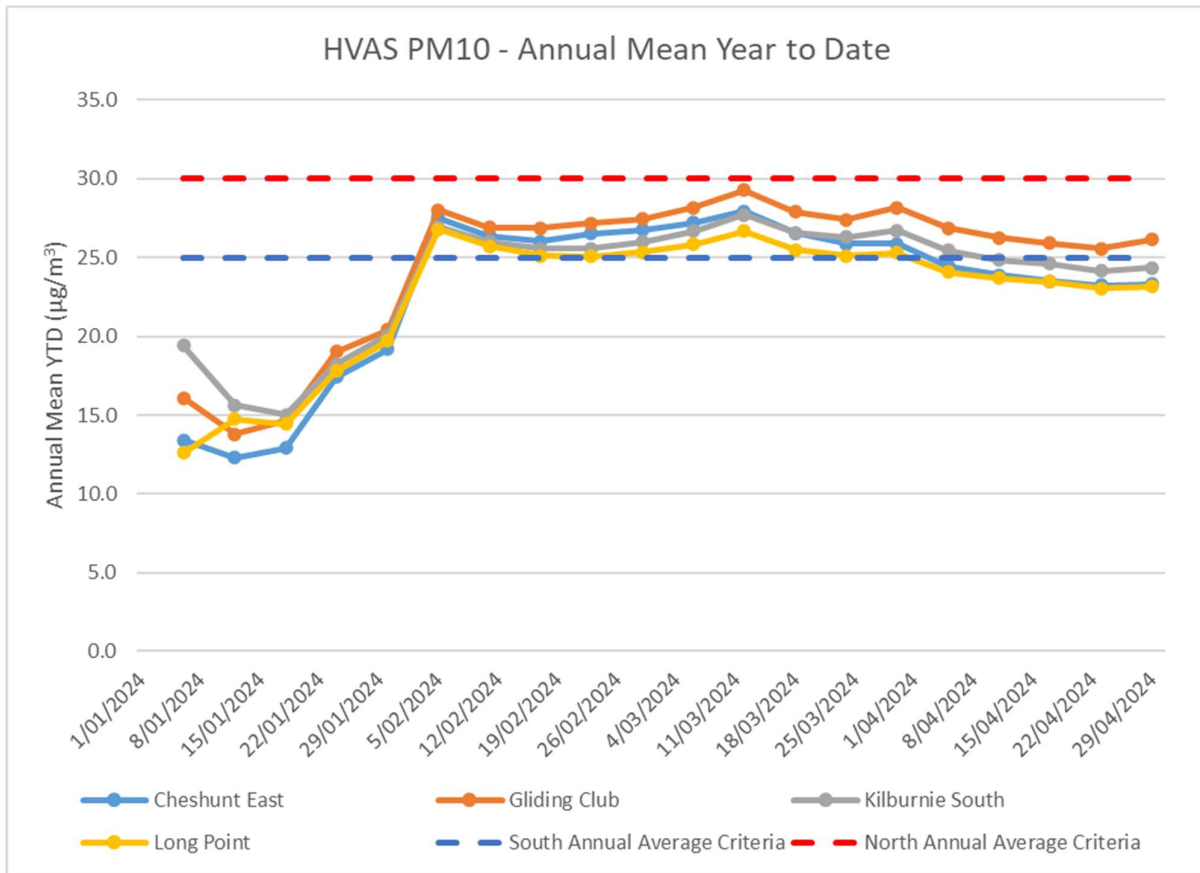
Figure 7 – Year to Date Average PM10 as at end of the Reporting Period

Figure 7 shows the year-to-date annual average PM10 results. The Gliding Club, Kilburnie South and Long Point monitors annual averages reported results greater than the relevant (South) long term impact assessment criteria during the reporting period. All other monitors were below the relevant (North) long term impact assessment criteria during the reporting period.

An assessment of HVO's contribution against the long-term impact assessment criteria will be provided in the 2024 Annual Review.

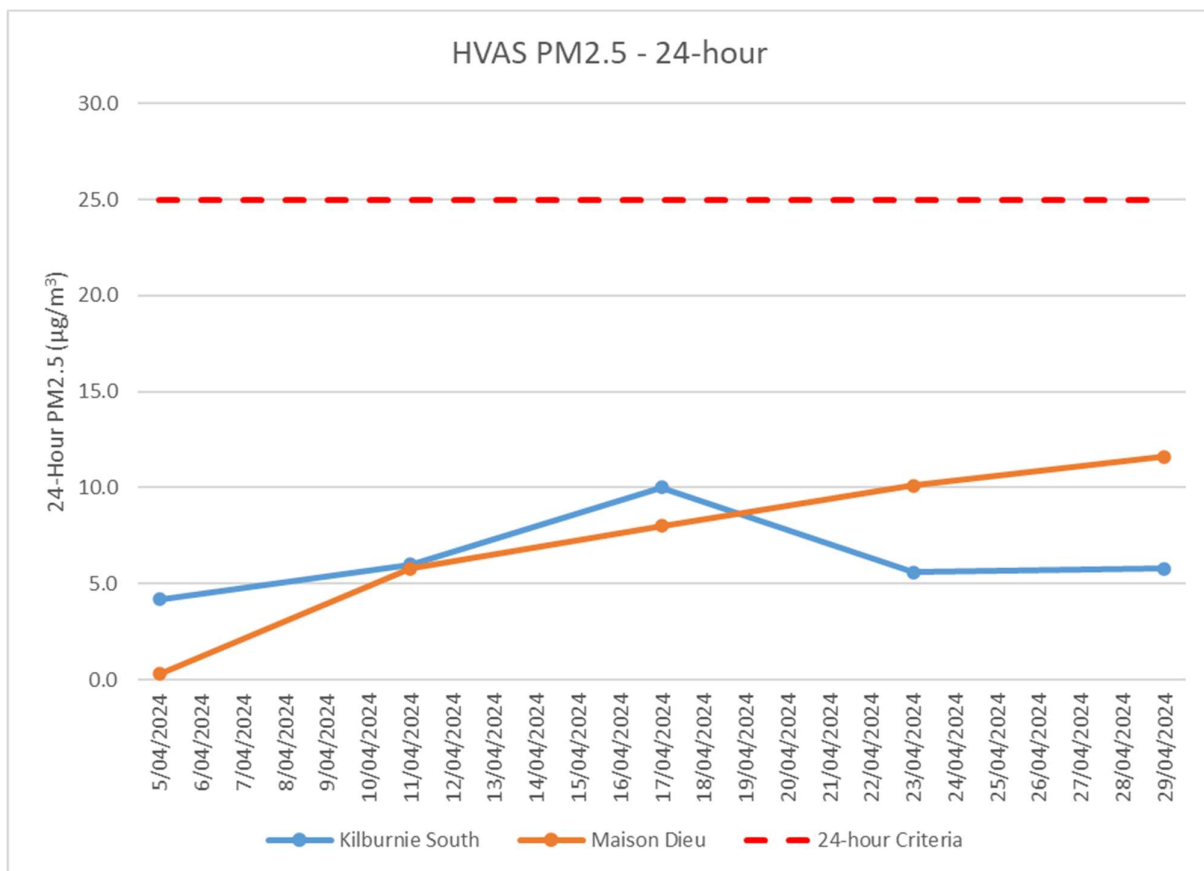
Figure 8 - Results for the Reporting Period

Figure 8 shows individual PM_{2.5} results at each monitoring station against the HVO South short-term impact assessment criteria of 25µg/m³ for the reporting period. Both monitors were below the relevant short-term impact assessment criteria during the reporting period.

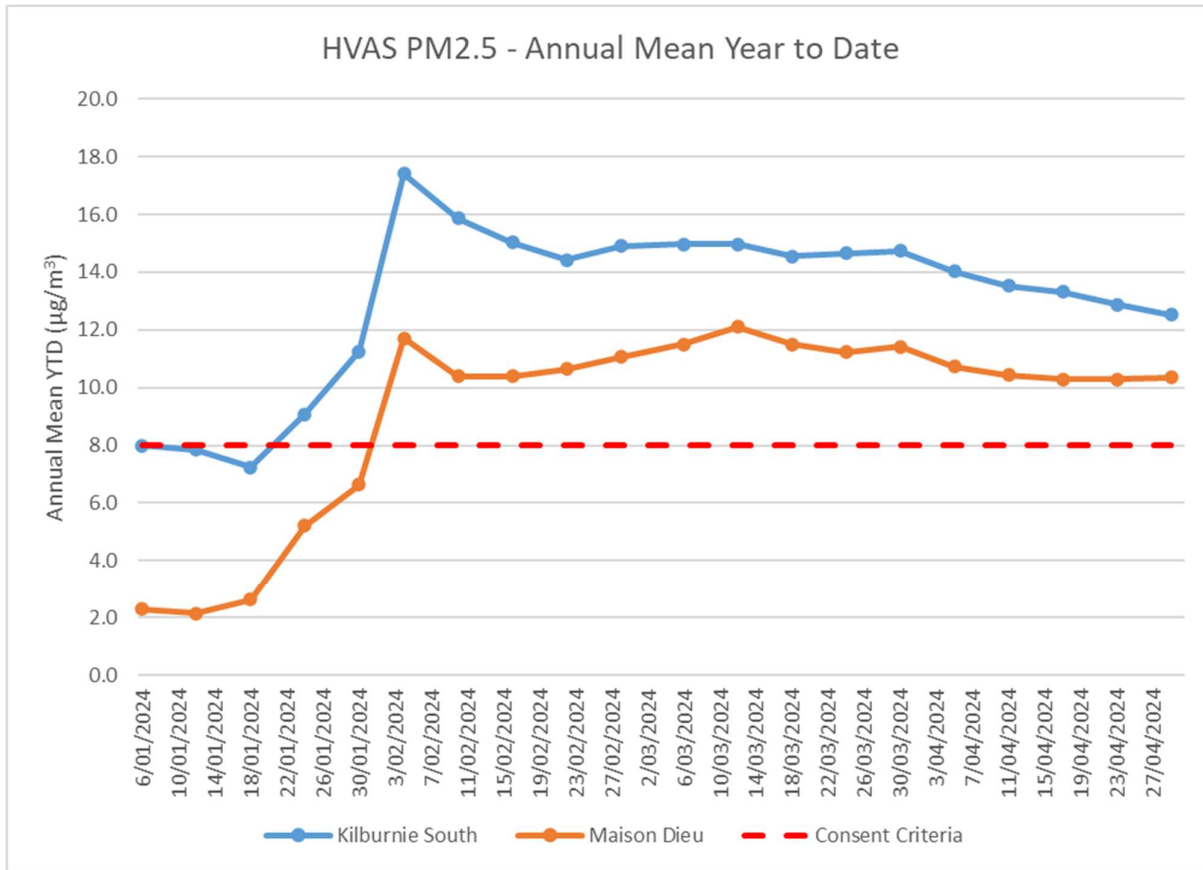
Figure 9 - Year to Date Average PM_{2.5} as at end of the Reporting Period

Figure 9 shows the year-to-date annual average PM_{2.5} results. During the reporting period, the Knodlers Lane and Warkworth monitors annual average year to date results were both above the PM_{2.5} Annual Rolling Mean criteria of 8µg/m³.

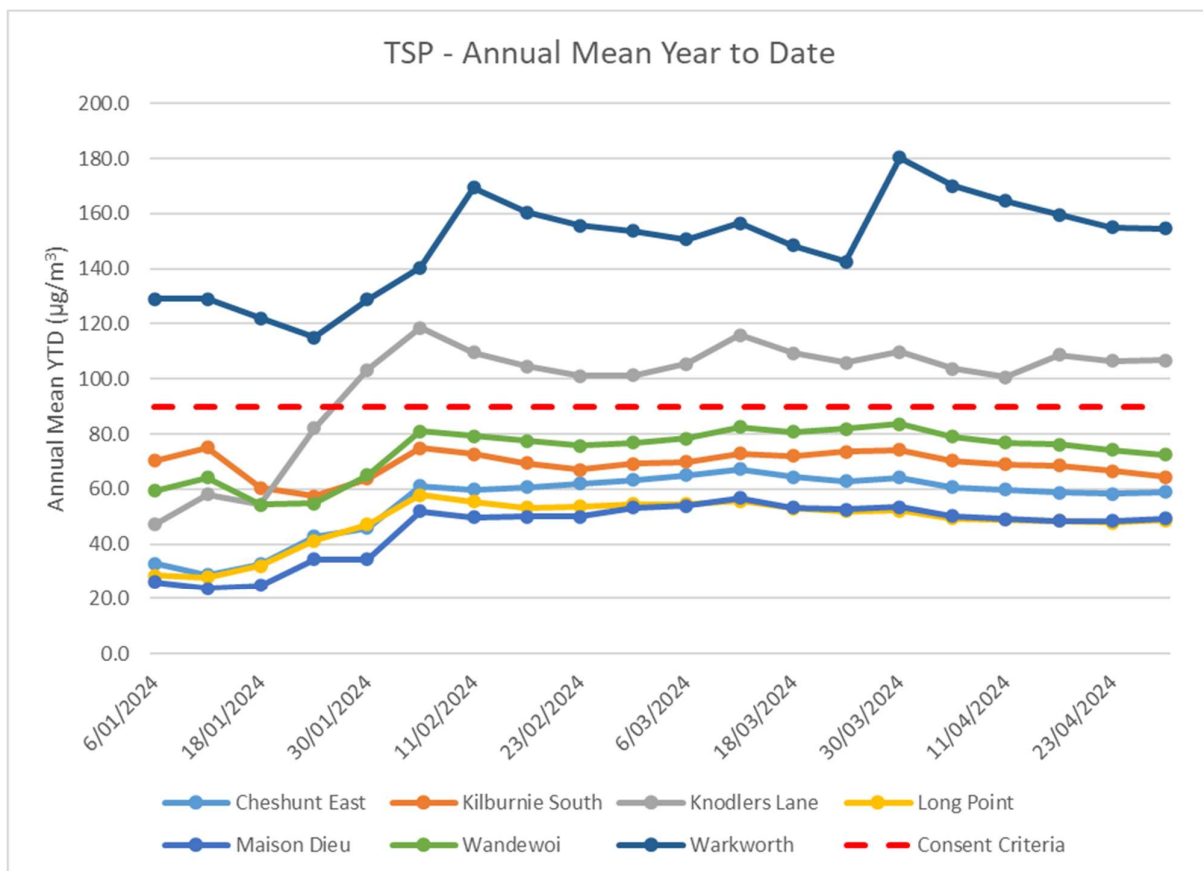
Figure 10 - Year to Date Average Total Suspended Particulates as at end of the Reporting Period

Figure 10 shows the annual average TSP results compared against the long-term impact assessment criteria of 90µg/m³.

All monitors, except for Knodlers Lane and Warkworth, were below the relevant long-term impact assessment criteria during the reporting period.

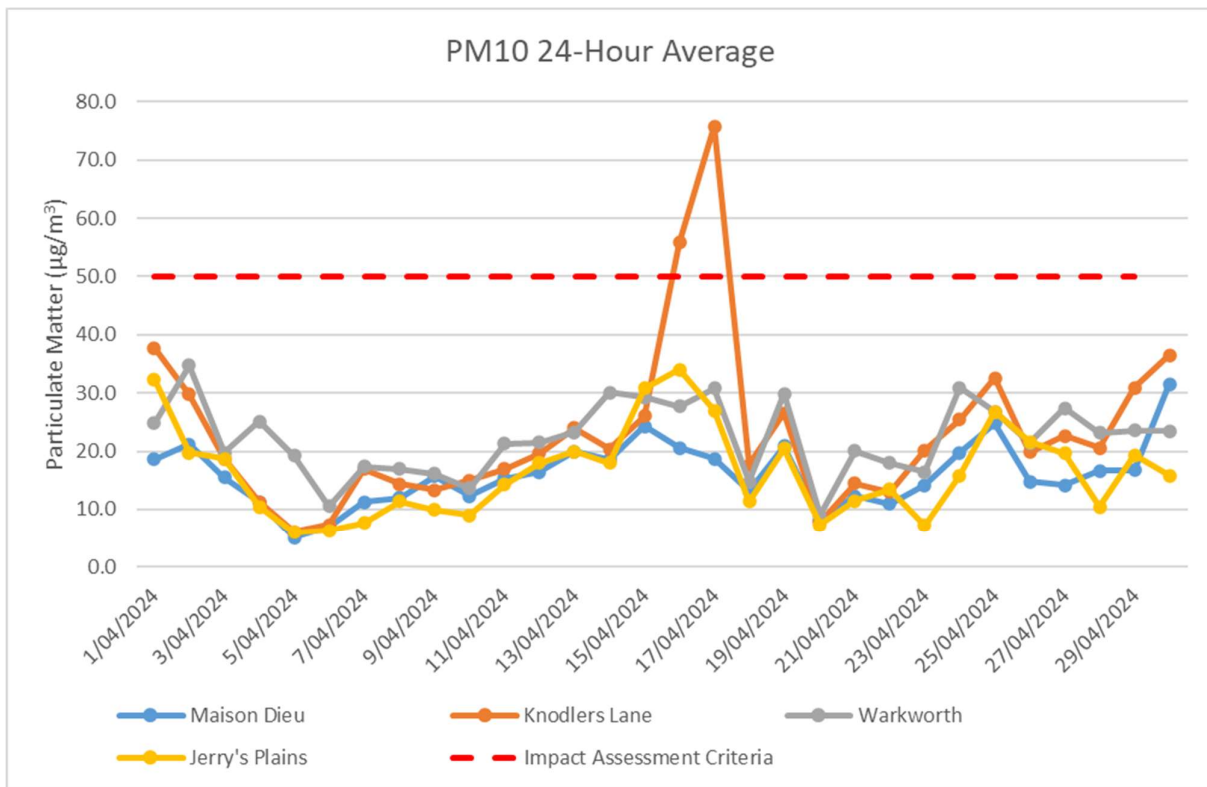
Figure 11 – Real Time PM₁₀ 24hr for the Reporting Period

Figure 11 shows the daily 24-hour average PM₁₀ result from the real time monitoring sites. During the reporting period, daily results were below the 24hr average criteria of 50µg/m³ with the exception of Knodlers Lane monitor on 16 and 17 April. These exceedances were investigated internally by HVO and it was found that the maximum calculated HVO contribution was below the compliance limit.

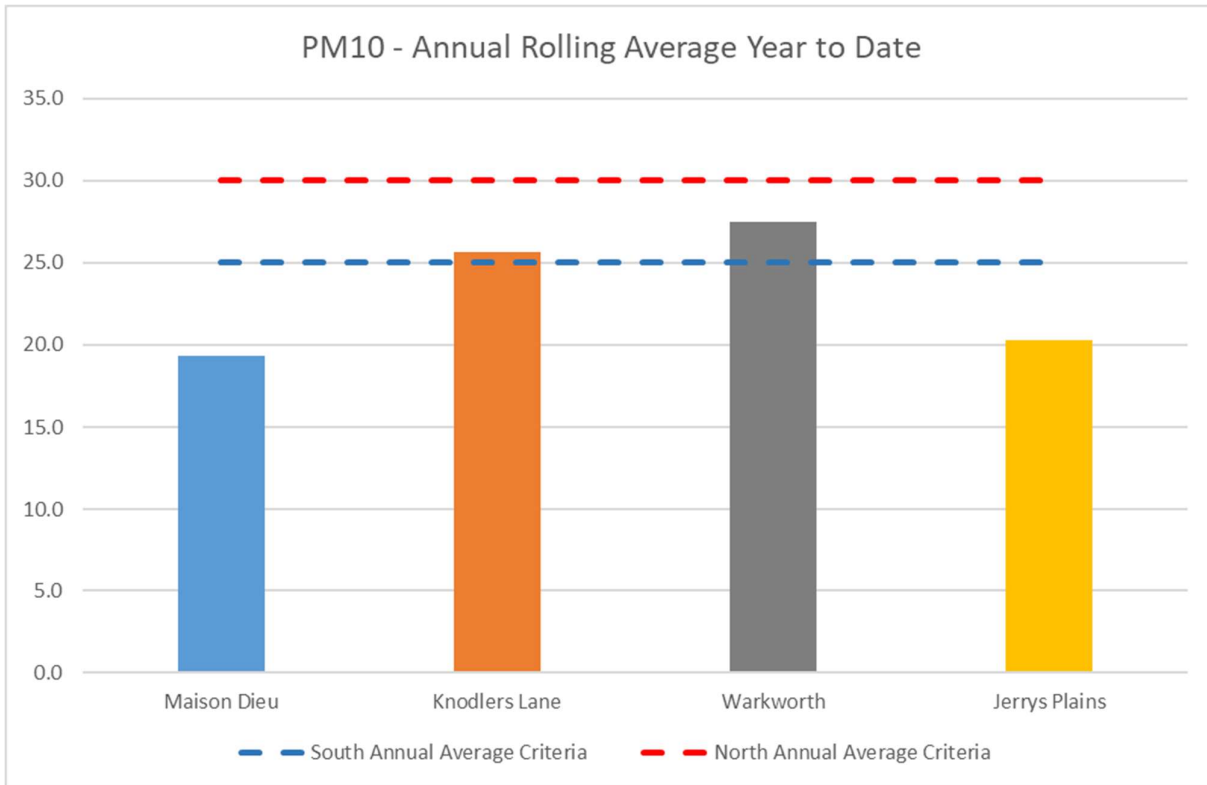
Figure 12 – Real Time PM₁₀ Annual Average for the Reporting Period

Figure 12 shows the annual rolling average PM₁₀ results from the real time monitoring sites. The annual average results for all monitors are currently below the relevant long-term impact assessment criteria for the reporting period.

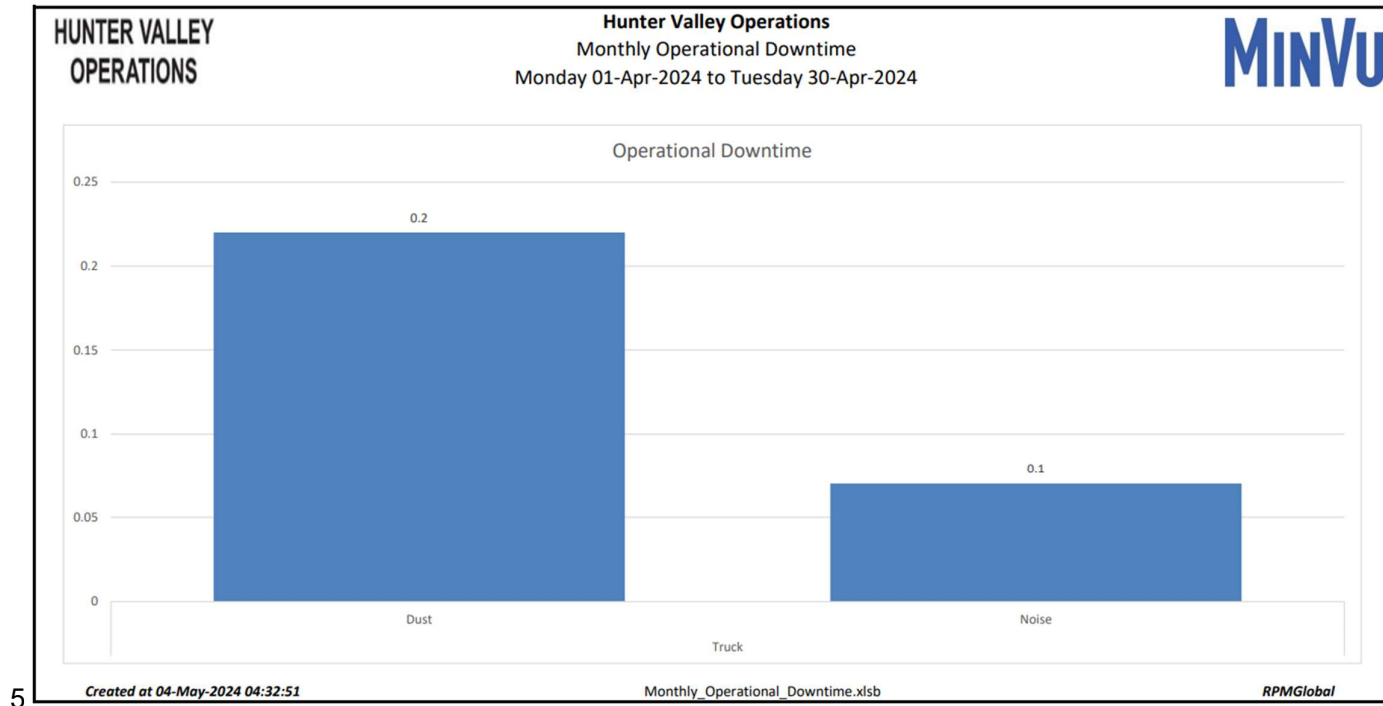
Figure 17 - Operational Downtime by Equipment Type for the Reporting Period

Less than one hour of equipment downtime was logged in response to real time monitoring and inspections for environmental factors such as noise and dust during the reporting period. Operational downtime by equipment type is show in **Figure 17**. Note that these delays are instances where operations were completely stopped and does not include occasions where operations were changed/modified but not stopped (e.g. changed from exposed dump to in-pit dump).

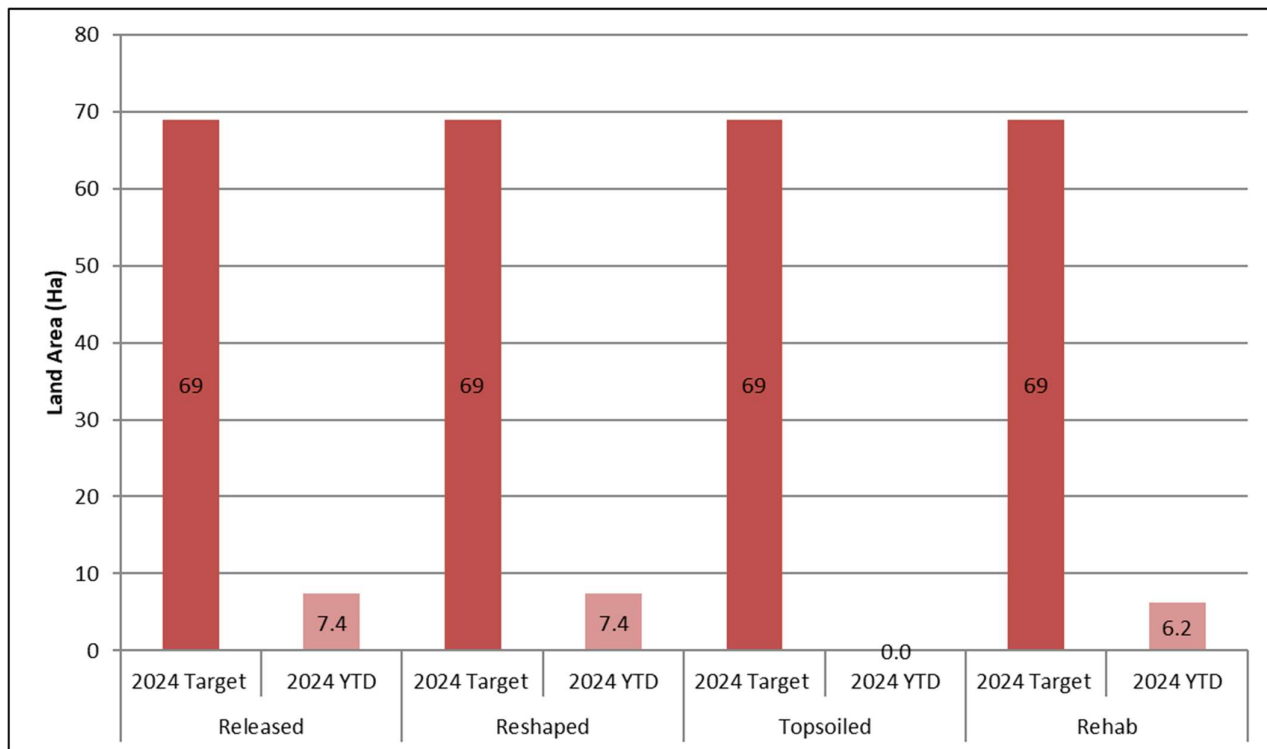
Figure 18 - Rehabilitation YTD April 2024

- 0.91ha of land was reshaped;
- 0.91ha of land was released (became available for the application of topsoil);
- 0.00ha of land was topsoiled; and
- 0.00ha of land was rehabilitated.

Year to date progress is shown in **Figure 18**.
